Challenges and Potentials of Retrofitting
Masonry Non-Engineered Construction in
Indonesia(Dissertation_全文)

**A Dissertation Submitted for the Fulfillment of
Doctoral Program
in Global Environmental Studies**

**Graduate School of Global Environmental Studies
Kyoto University
Japan**

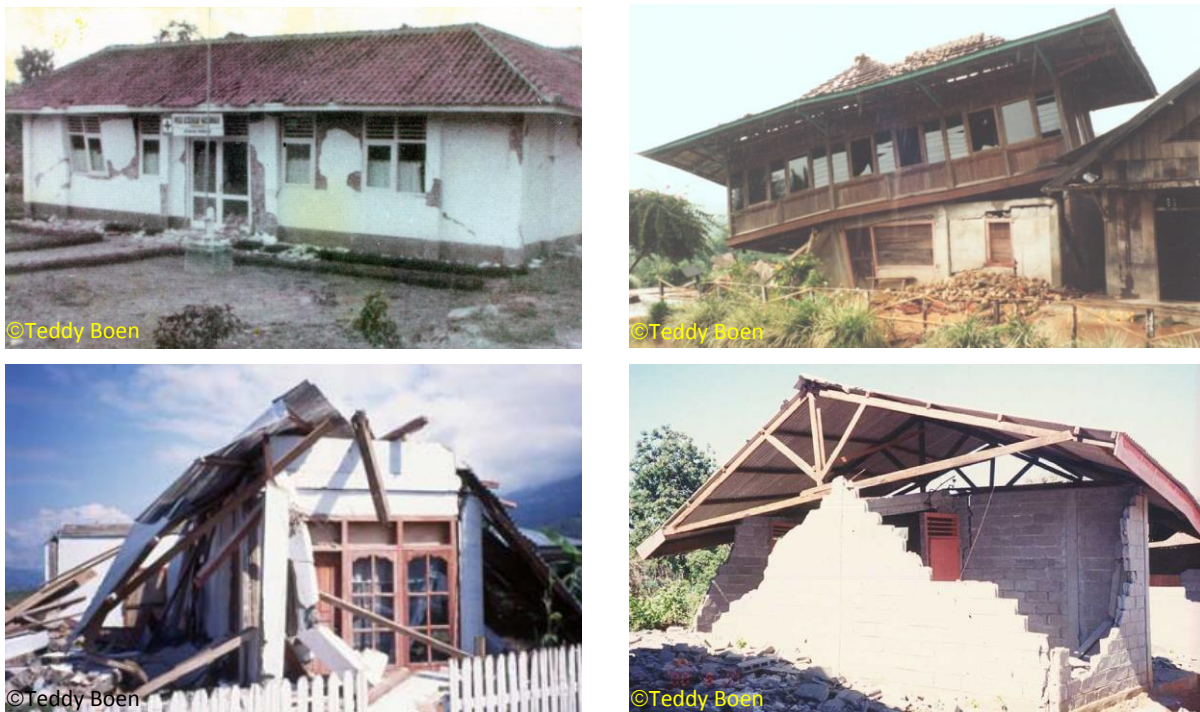
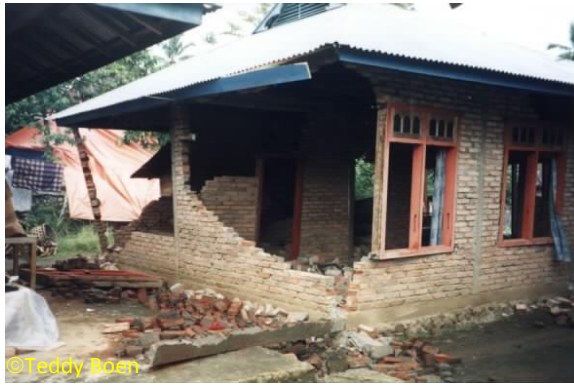
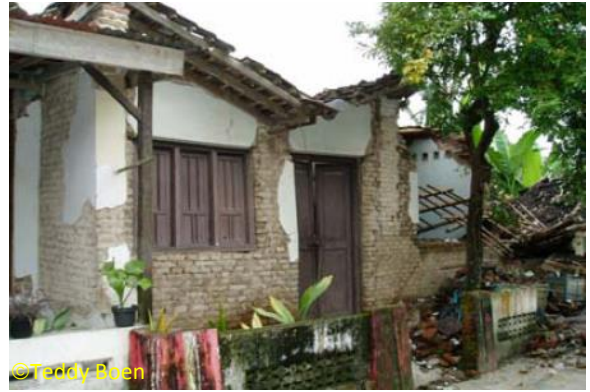
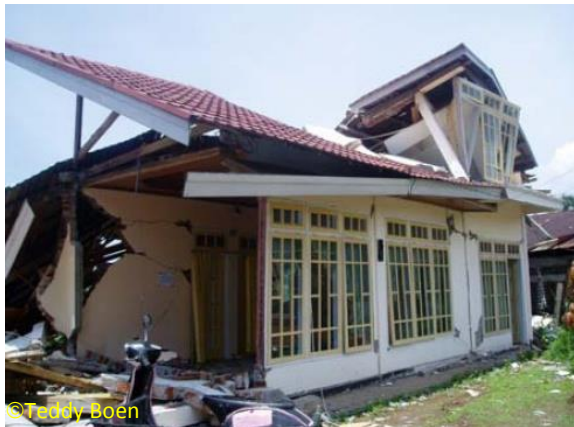
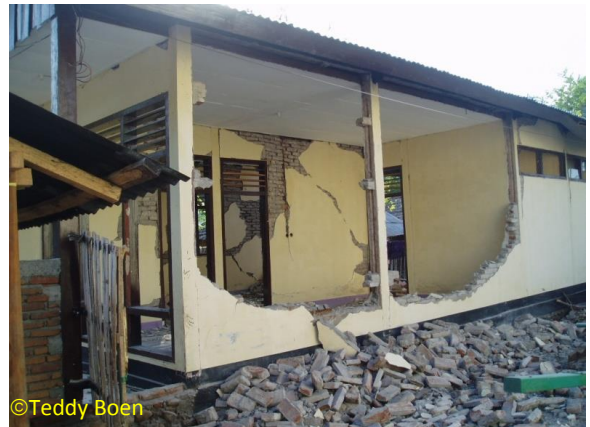
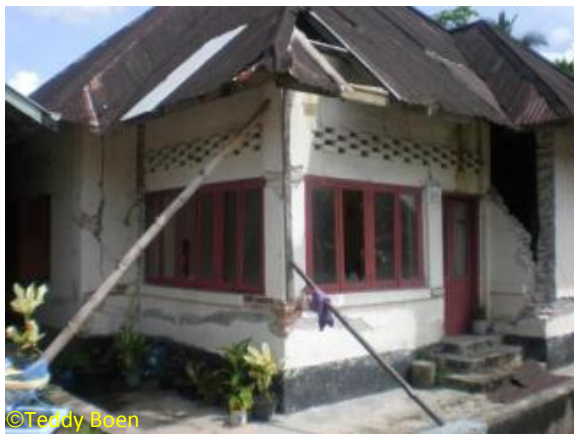
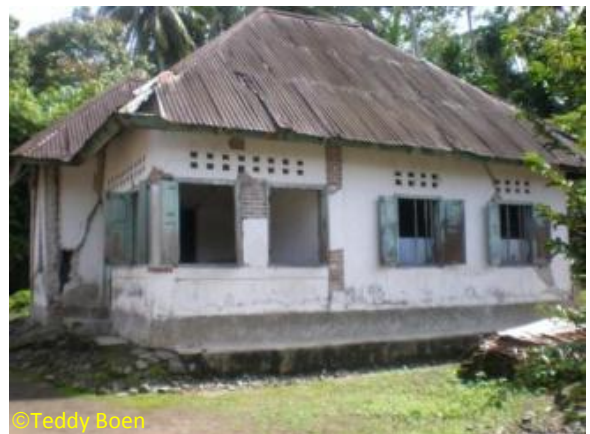
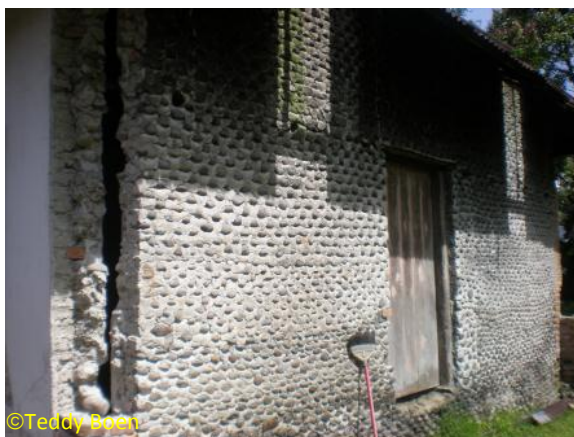
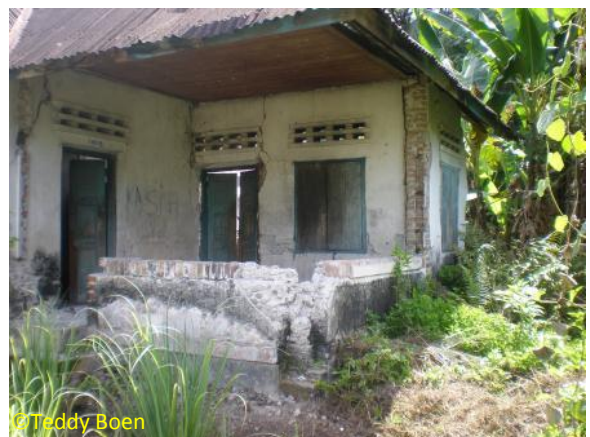
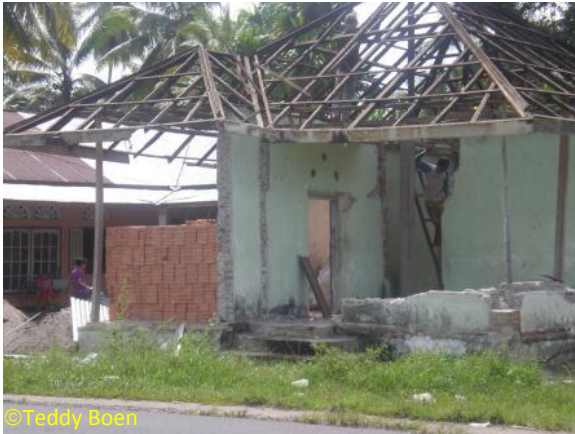
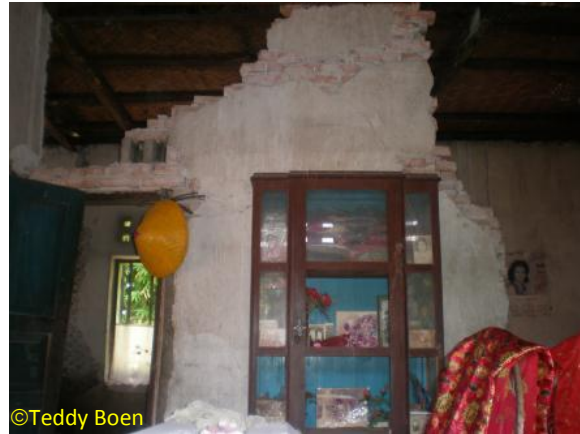
Figure 1 – Example of Houses that can be Retrofitted

Figure 1 (cont'd) – Example of Houses that can be Retrofitted

not aware that their buildings do not have to be demolished. The retrofitting cost is much less than the cost to build a new one. Moreover, the time required to retrofit is also shorter compared to building new ones. Figure 1 shows example of houses that can be retrofitted. This is very true and valid for one- or two-story school buildings which can be categorized as non-engineered.

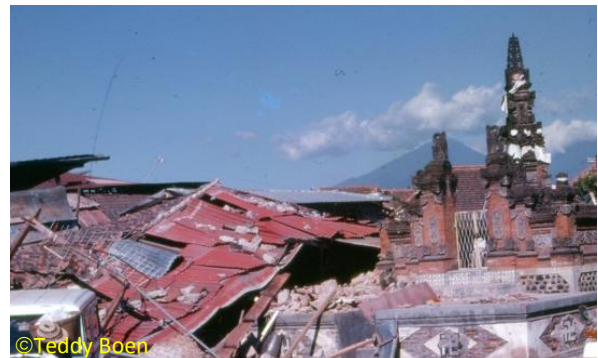
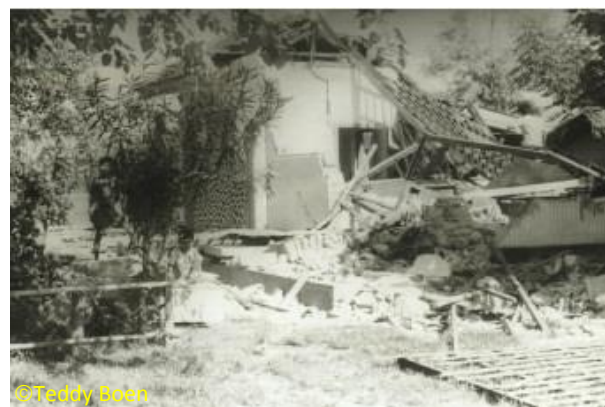
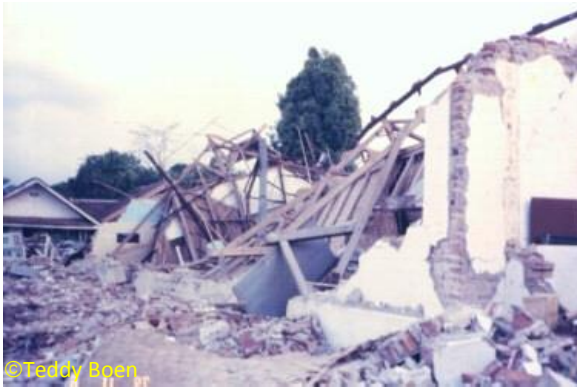
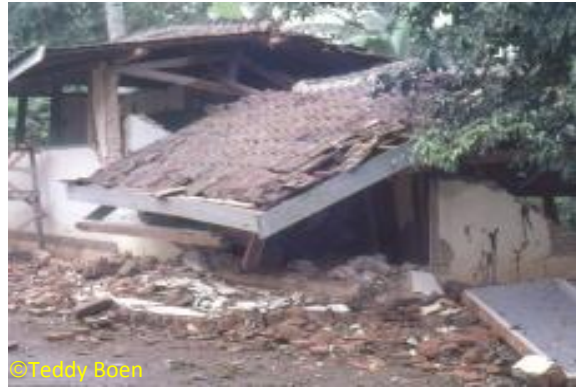
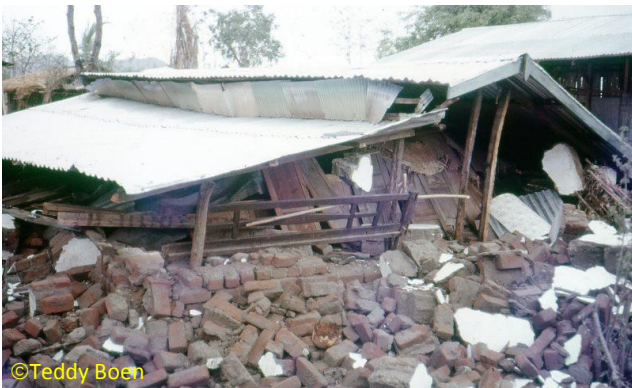
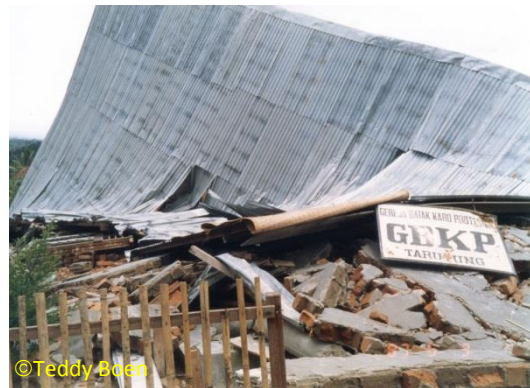
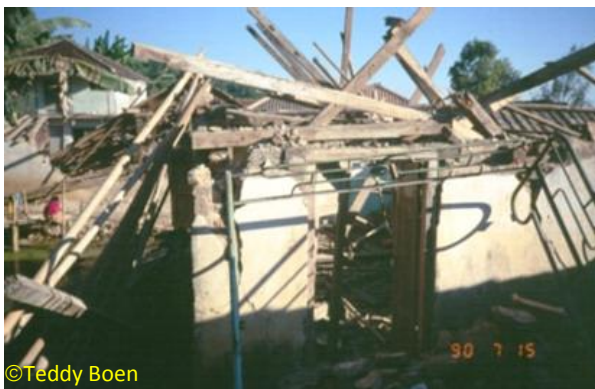
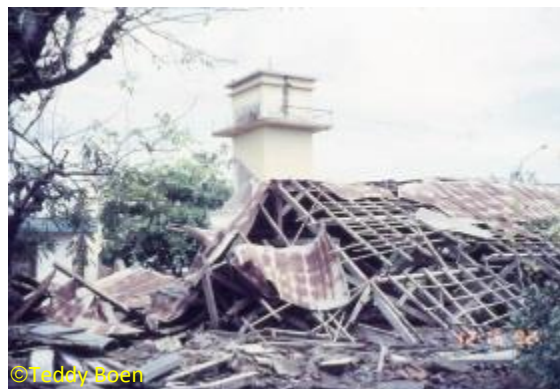
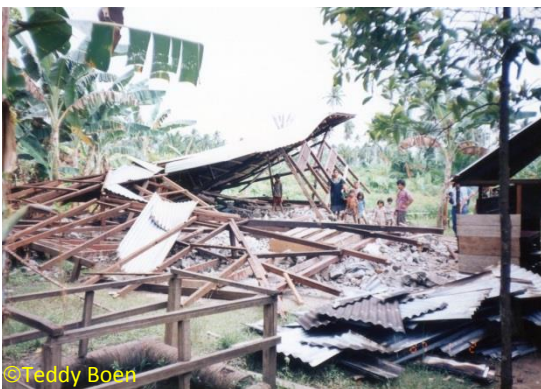
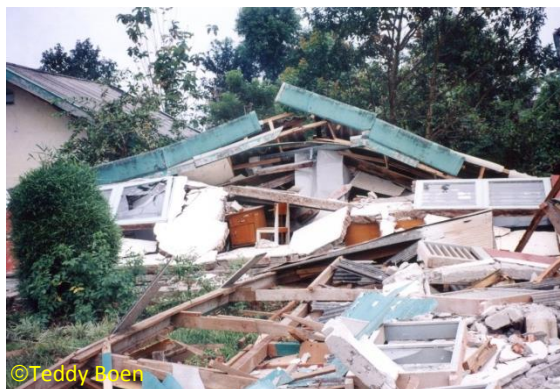
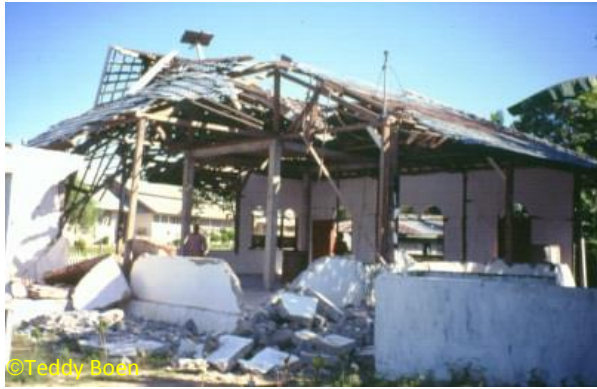
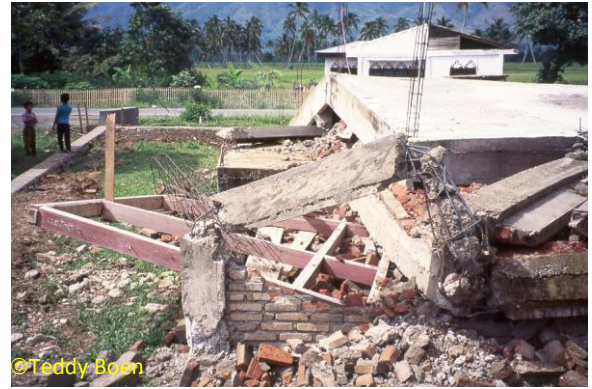
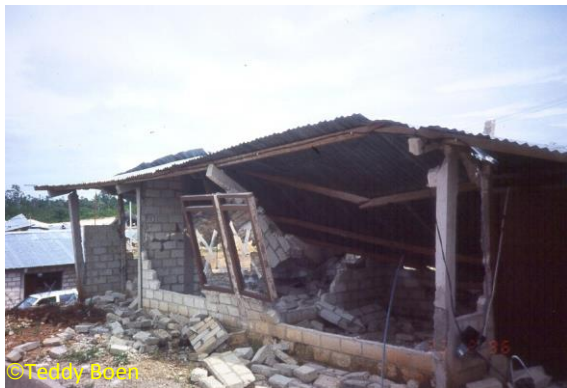
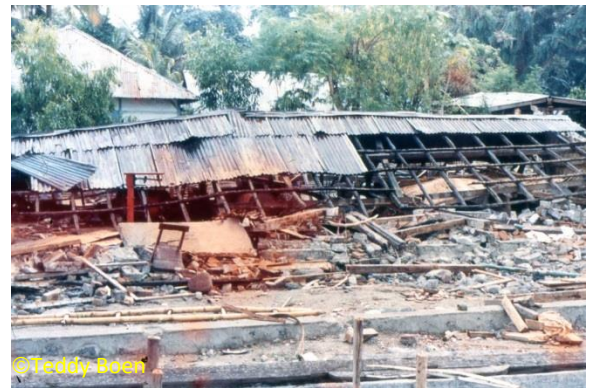
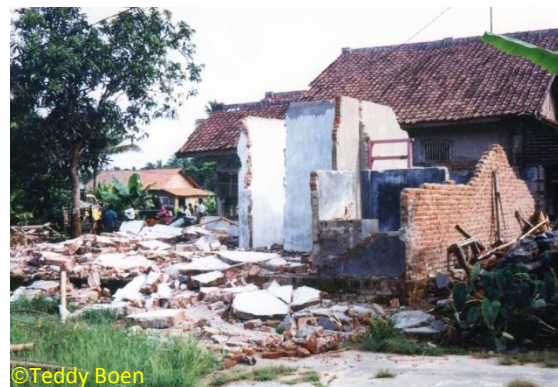
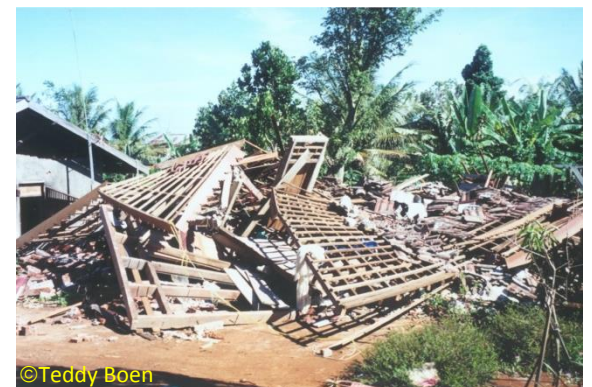
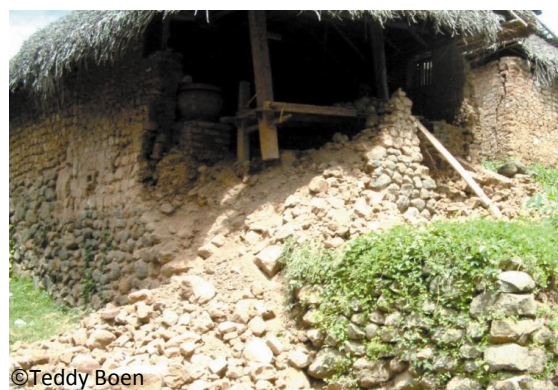
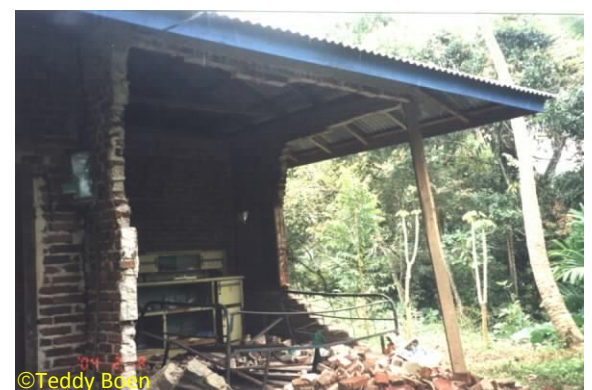
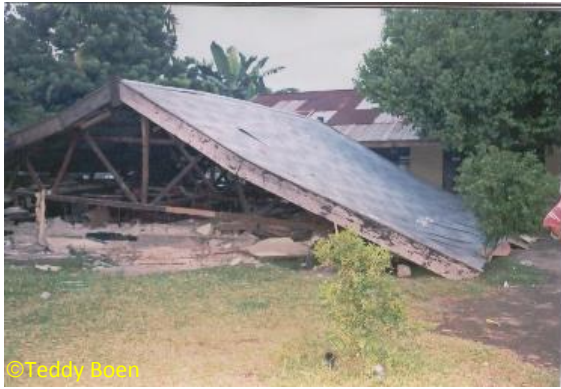
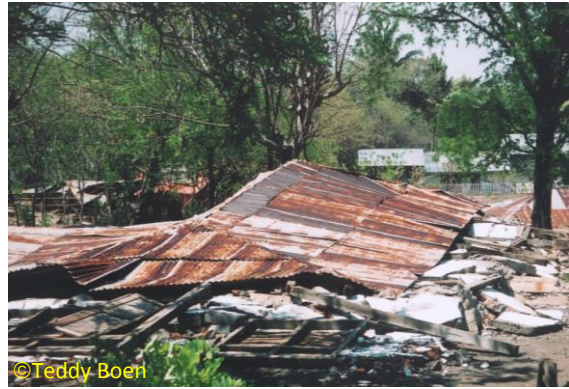
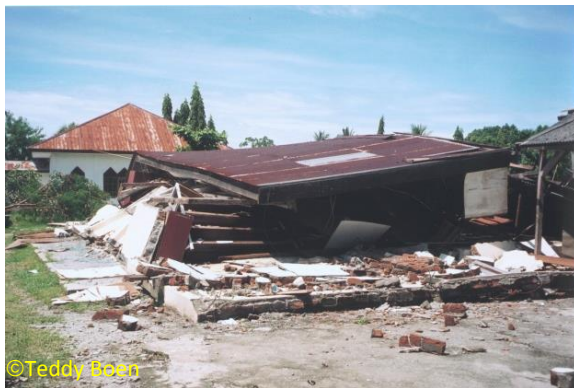
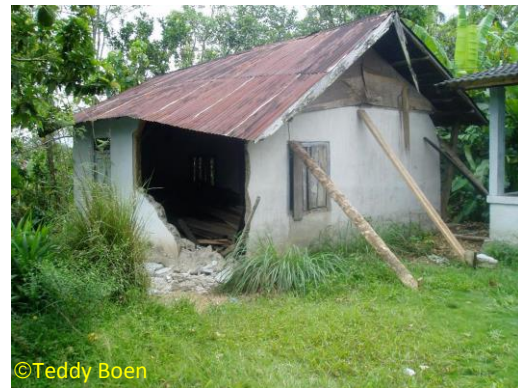
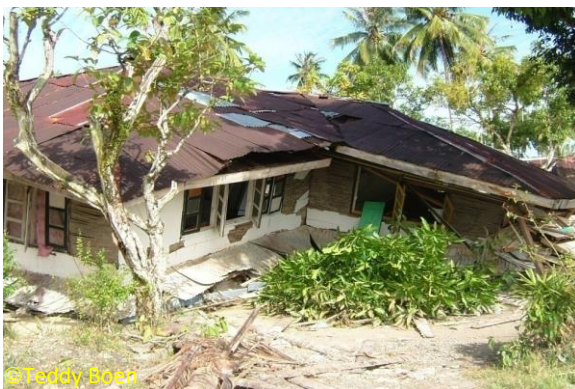
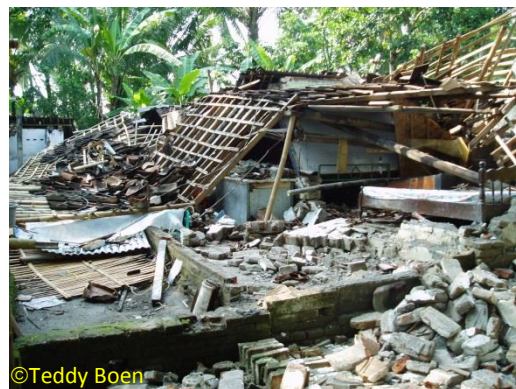
Figure 6 – Damage of Non-Engineered Constructions due to Earthquakes in Indonesia

Figure 6 (cont'd) – Damage of Non-Engineered Constructions due to Earthquakes in Indonesia

Almost every year earthquake disasters occur in many places in different parts of Indonesia and cause damage and destruction of buildings. Most of the damaged and/or collapsed buildings are people's houses so called as non-engineered constructions (Figure 6). Despite of the many human casualties and the severe impact on the regional economy and development, it seems that relatively little is being done to prepare, prevent or mitigate the effects of future earthquakes. The earthquakes are repetitions of all past occurrences and are a demonstration that not much has been done with regard to non-engineered constructions. This is clearly demonstrated by the July 2, 2013 earthquake in Aceh Tengah and Bener Meriah in Aceh Province, where many non-engineered houses are heavily damaged and collapsed, taking 36 lives.

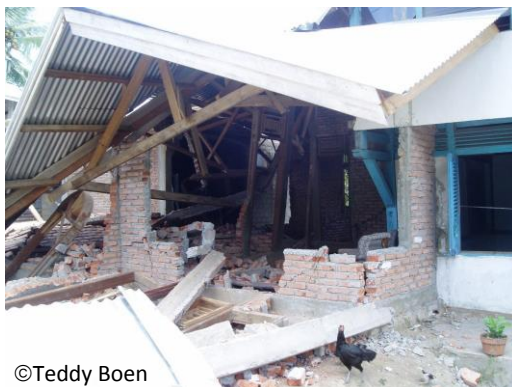
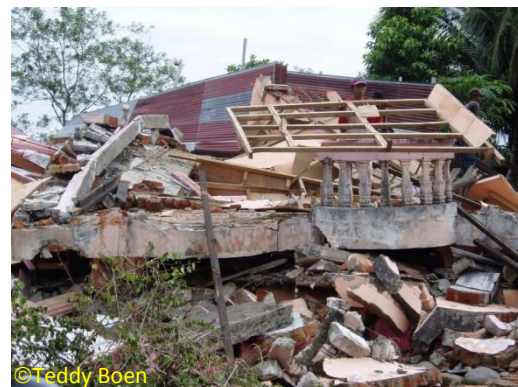
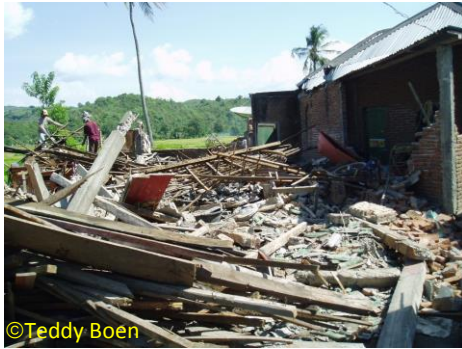
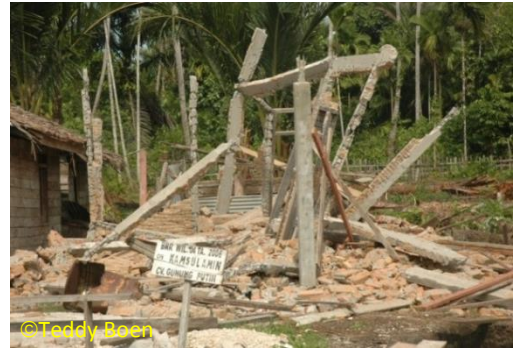
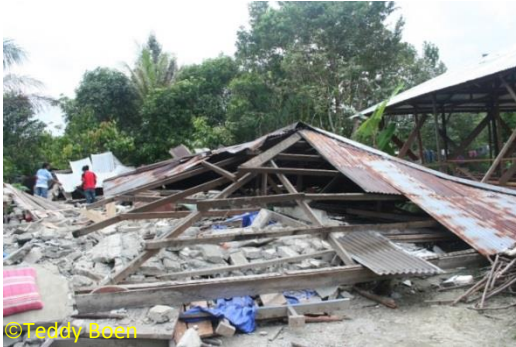
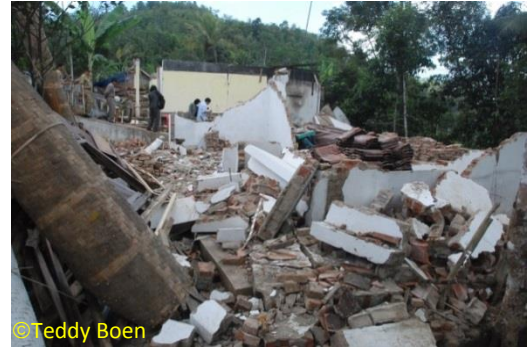
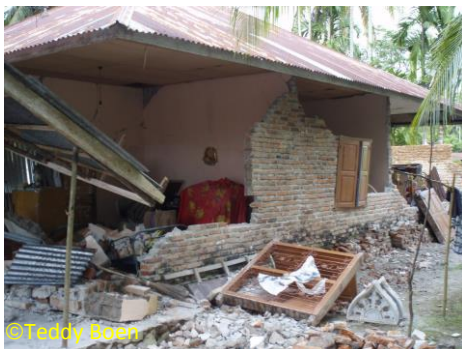
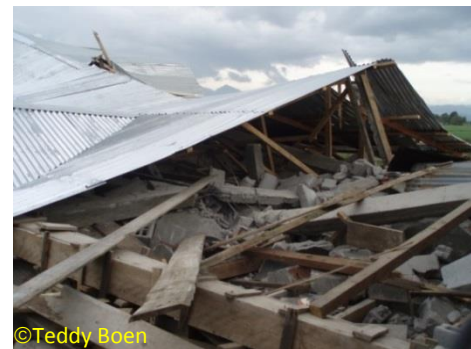
Figure 6 (cont'd) – Damage of Non-Engineered Constructions due to Earthquakes in Indonesia

The damages that occurred in Yogyakarta, West Sumatra, Bengkulu, Dompu, Simeulue, West Java, West Sumatra, and Aceh showed that simple houses collapsed claiming human lifes. In Yogya, after the 2006 earthquake, JICA introduced a Building Permit System (BPS) for simple houses in villages; however, so far the code for non-engineered constructions is not yet developed. A BPS is part of an enforcement to build earthquake resistant houses.

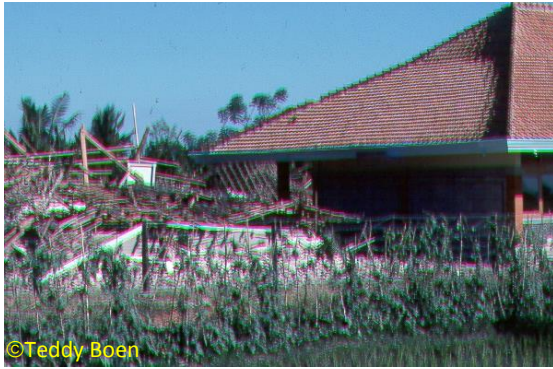
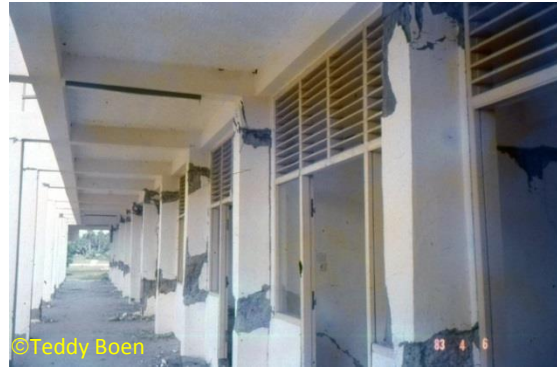
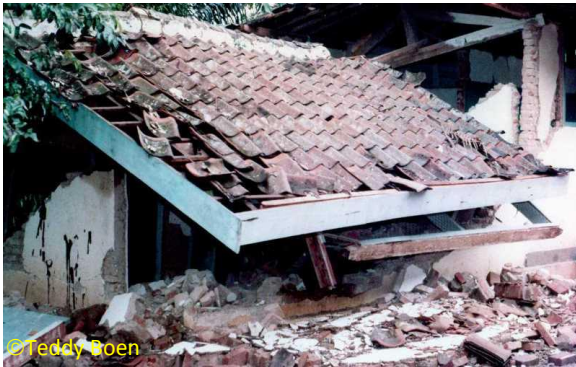
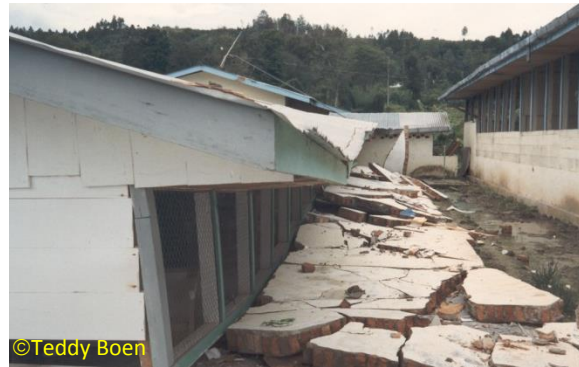
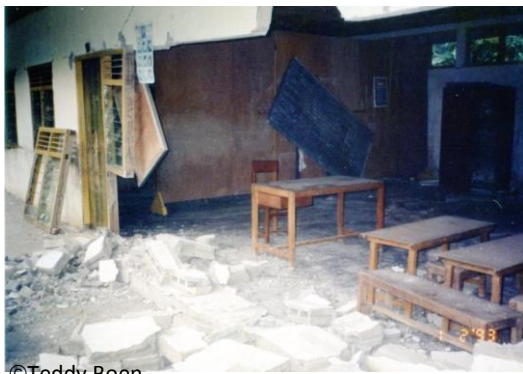
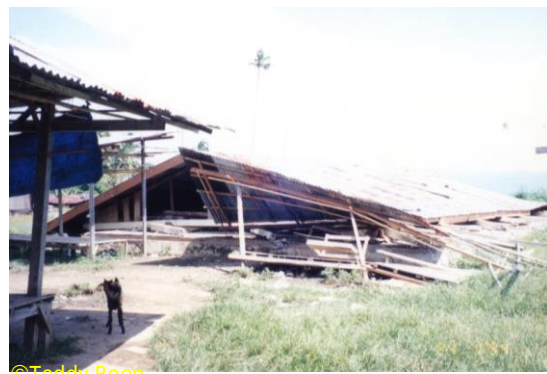
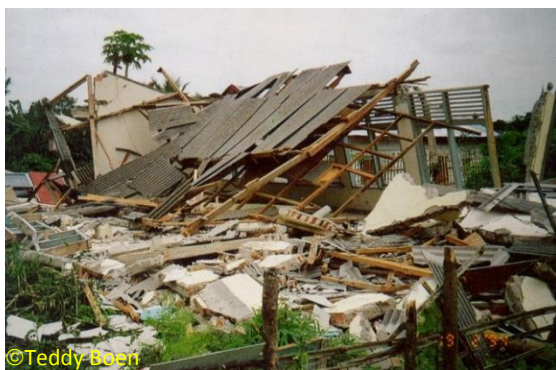
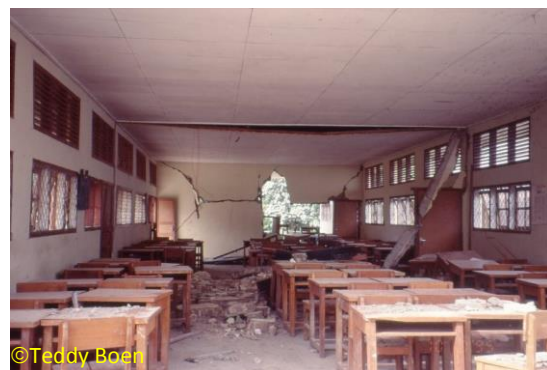
Figure 7 – School Buildings Damage due to Earthquakes in Indonesia

One- and / or two-story school buildings in Indonesia can be considered as non-engineered constructions and also, like other non-engineered constructions are often damaged and destroyed when shaken by earthquakes (Figure 7). They are even more vulnerable due to larger spacing between walls in both directions if compared to residential buildings. Failure of schools may result in cutting short the lives of the future intelligentsia in a country and cause terrible upsetting to the parents of the children who lose their lives. Needless to say that collapsed and or damaged school buildings will disrupt the education activities.

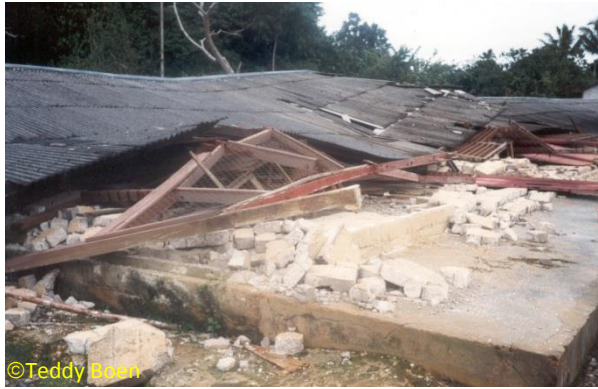
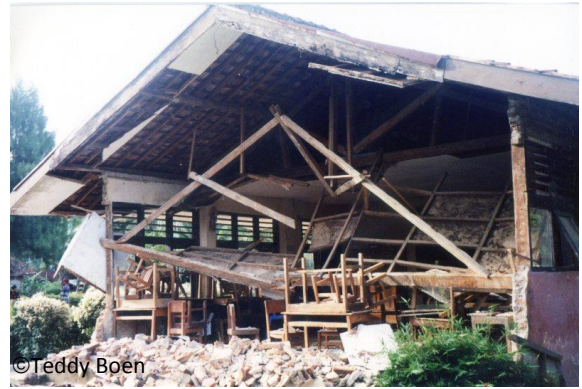
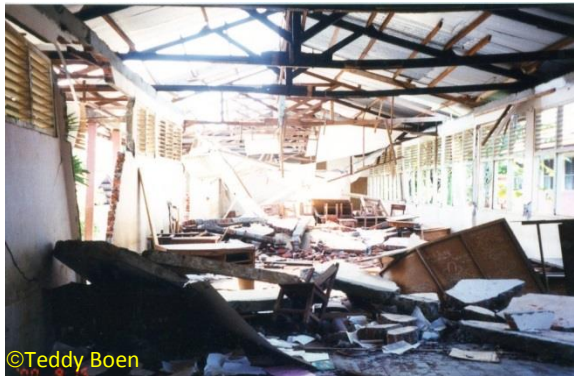
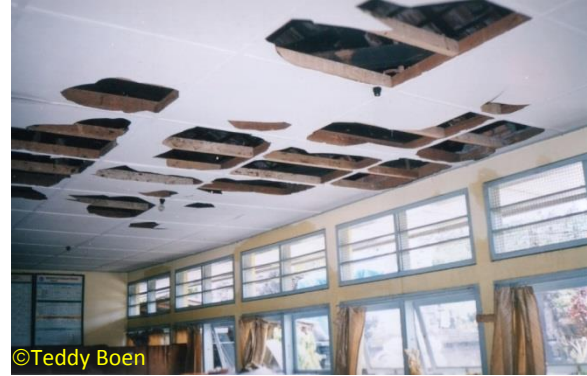
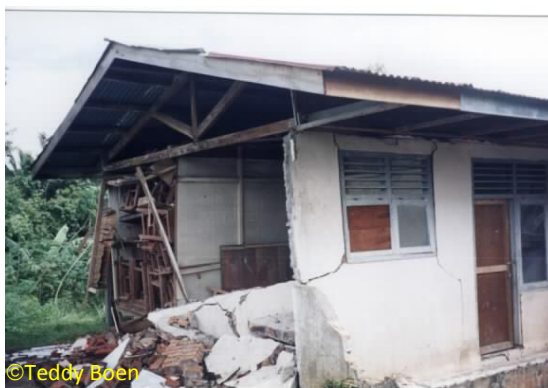
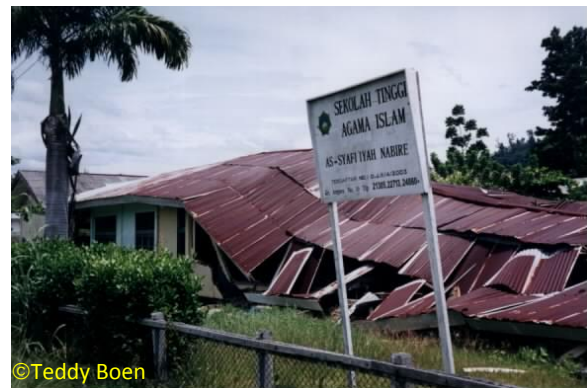
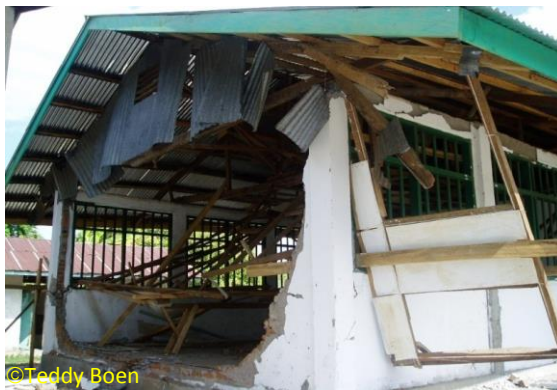
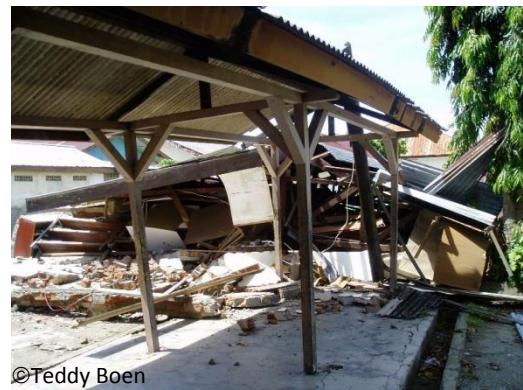
Figure 7 (cont'd) – School Buildings Damage due to Earthquakes in Indonesia

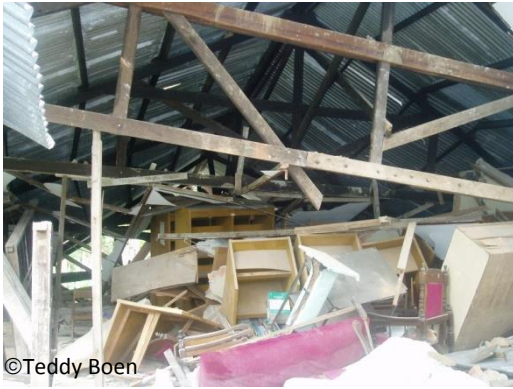
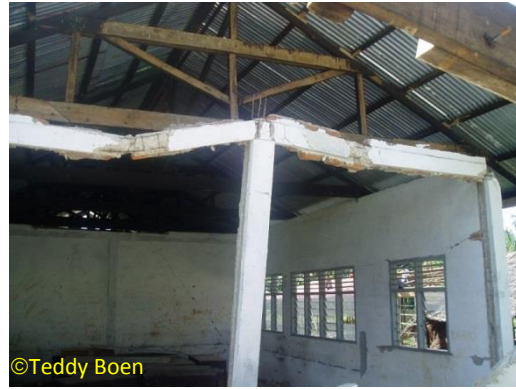
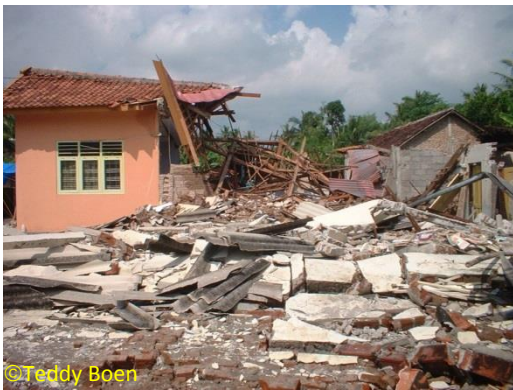
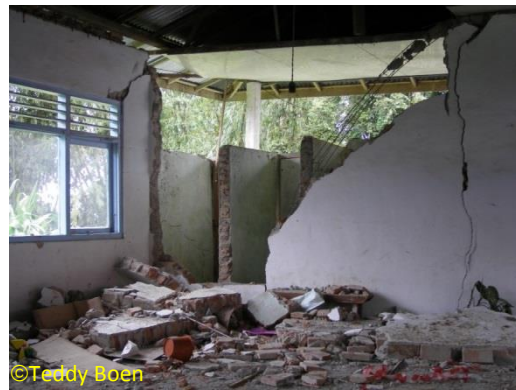
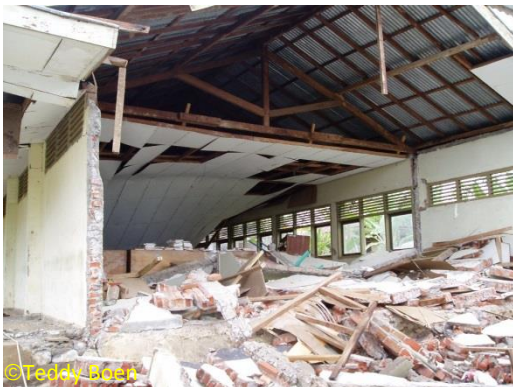
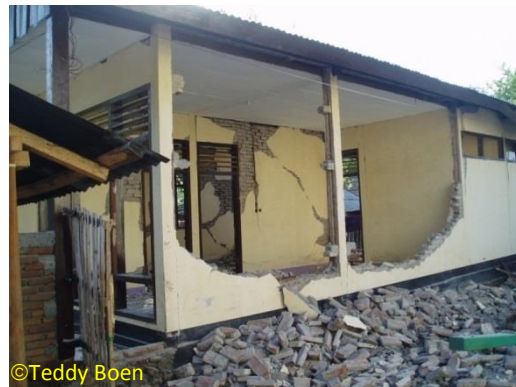
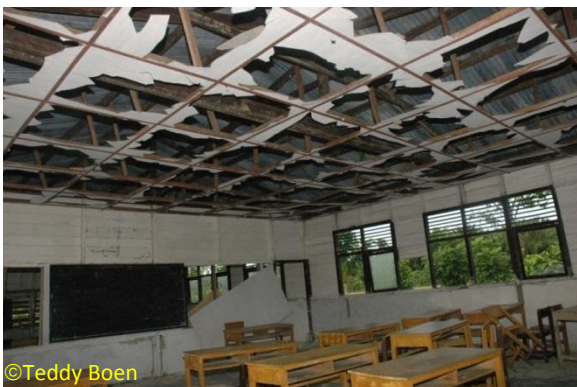
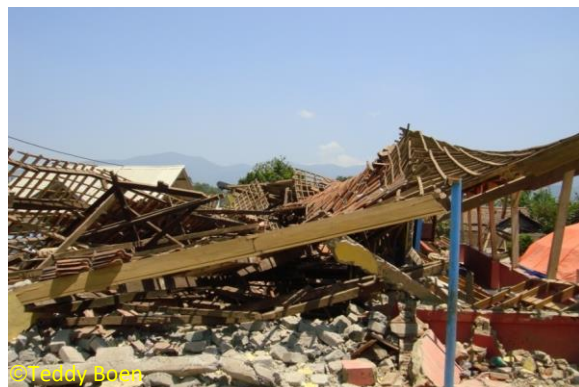
Figure 7 (cont'd) – School Buildings Damage due to Earthquakes in Indonesia

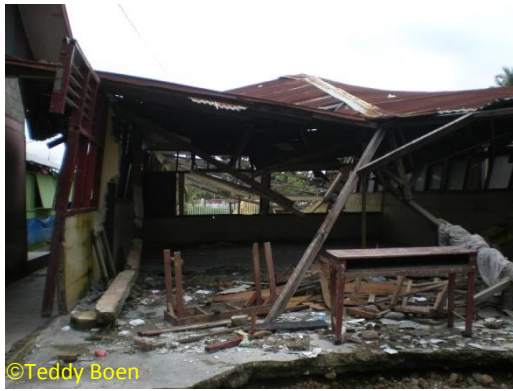
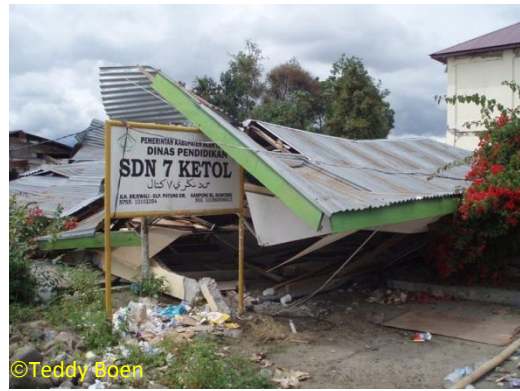
Figure 7 (cont'd) – School Buildings Damage due to Earthquakes in Indonesia

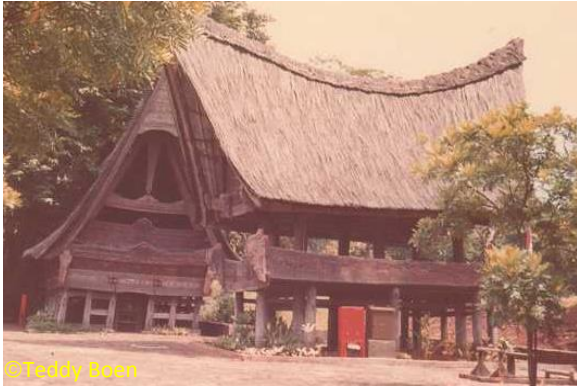
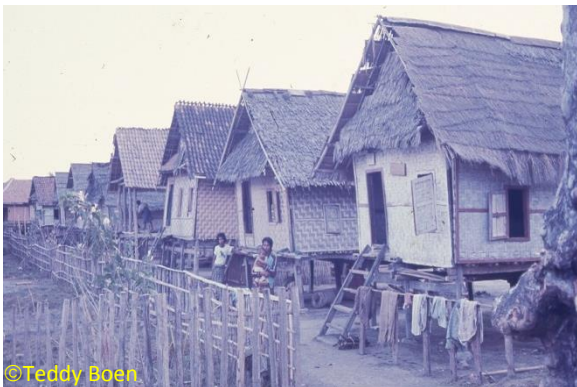
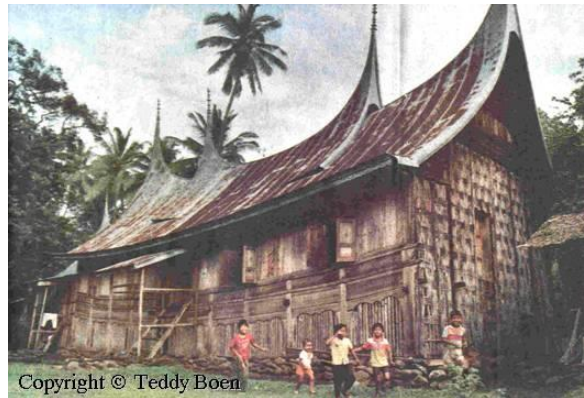
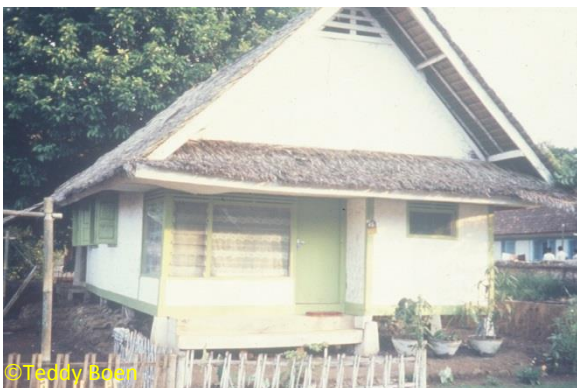
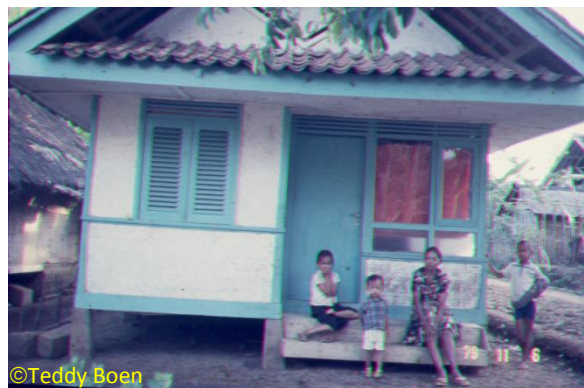
Figure 13 – Traditional / Indigenous Buildings

The traditional buildings generally have a good record or good performance in past earthquakes. This is due to the fact that man and nature have co-existed on the planet of earth for a long time. Since the primitive days man has tried to adjust himself to the conditions of environment and made feeble attempts to cope with the fury let loose by forces of nature. The pattern of human settlements and traditional methods and materials for traditional buildings on regional basis embody the accumulated traditional wisdom,

experience, skill, and craft evolved through the ages. Some of the buildings which have existed for centuries have withstood the onslaughts of earthquakes. However, due to urbanization, the trade of building those traditional, vernacular houses is not being transferred. Almost all young people from villages are moving to cities in search for a better living. As soon as they are successful, they return to their respective villages and tend to build masonry houses as a show off of their success.

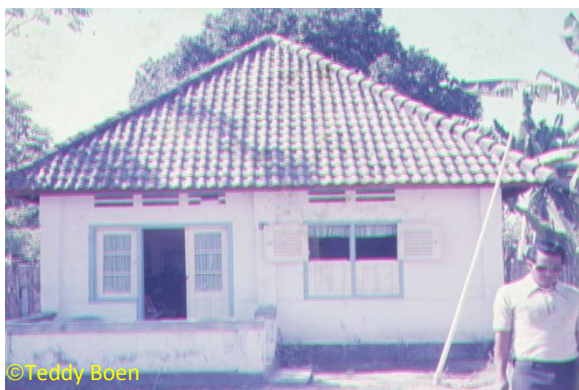
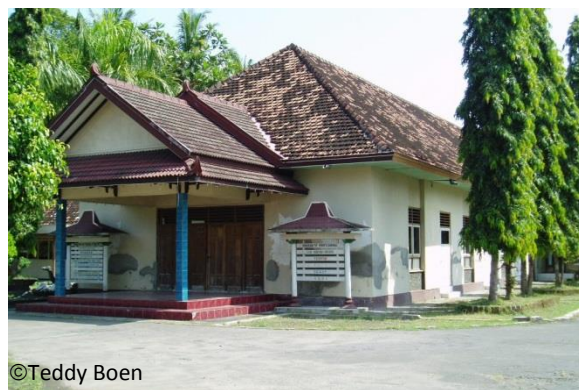
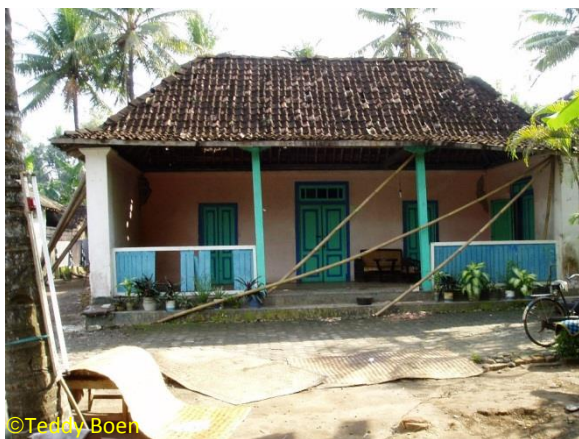
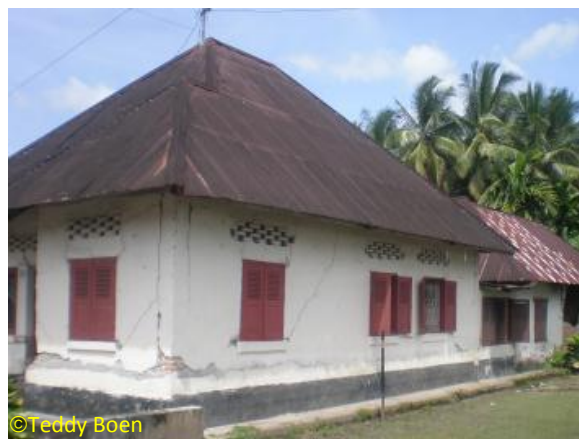
Figure 14 – One-brick Thick Masonry Buildings

Most of the one or one and half-brick-thick masonry buildings built in accordance to Dutch tradition are very old and many are dilapidated due to lack of maintenance. As can be observed in many other earthquake disasters, there is a relationship between the age of the buildings and their quality particularly in non-engineered constructions. The deterioration of the materials, in particular the mortar, contributed to many of the damages and / or collapses of such one- or one-and-half-brick-thick masonry buildings. It was also observed that the lack of integrity between the various components, the foundation, the walls and the roof. Inadequate connections are causing the building to tear apart. Proper connections and detailing must be developed to improve the structural integrity of the non-engineered masonry buildings of this category. Non-engineered constructions in this category consist of houses, small shops as well as religious and one story school buildings (Boen, 2006).

Masonry buildings were introduced by the Dutch when Indonesia was a colony of the Dutch hundreds of years ago. This type of masonry buildings is copied from Europe and consists of one brick thick walls, using brick pilasters without any reinforced concrete columns and beams as confinement. At that time the Dutch used mortar mix consisting of burnt brick powder, lime powder and sand, mixed with water. Some used pozolan and lime mix as mortar. The strength of this type of mortar mix can be maintained provided that certain moisture content is maintained. During the Dutch occupation all such buildings were annually white washed with lime mixed with water. Such layer of paint is porous and during rainy season, rain water / moisture can penetrate and will be absorbed by the mortar, therefore the moisture content was maintained. Since the moisture content is maintained, the strength of the mortar is retained. However, with the introduction of new building materials, particularly in the past 40 years, including the introduction of acrylic, weather shield paints, most of the houses are painted with acrylic based paints. Acrylic seals the masonry wall surface and rain water can hardly penetrate. Therefore the moisture content in the mortar is not maintained and this makes the mortar very brittle. Thus the masonry wall becomes brittle and easily disintegrated when shaken by an earthquake. However, from the damage survey, in actuality, many of the masonry buildings following the Dutch tradition but built in the colonial era can still be found all over Indonesia, particularly in Pariaman, Bukittinggi, West Sumatra, in Yogya and Mid Java, used sand and lime only as mortar. This is apparently a common practice. The strength of lime and sand mortar is less than if mixed with burnt brick powder and this is also one of the causes of brittle failure. The foundation of most of this category buildings are river stone foundation without reinforced concrete foundation beams. Roof trusses are usually embedded in walls without proper anchoring (Boen, 2006).

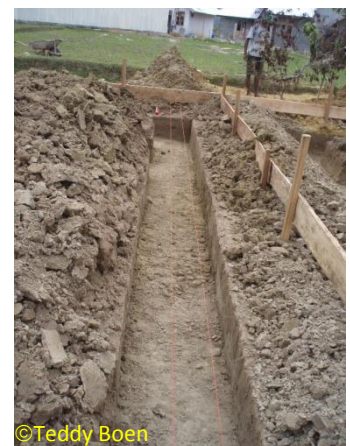
Figure 29 – Foundation Excavation

After all batter boards are constructed, the foundation excavation is done (Figure 29). The minimum depth and width is 80cm, and depends on the foundation dimension.

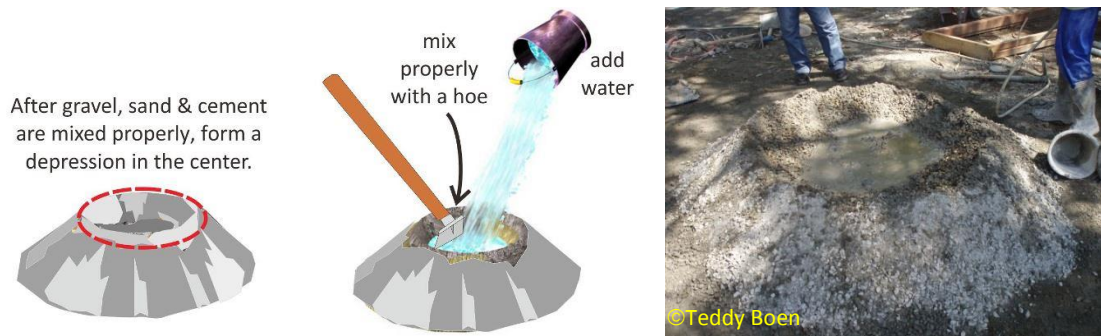
Figure 32 – Preparing Concrete Mix

The ratio of water : cement : sand : gravel that meets standard requirement is 1:2:4:6 or $\frac{1}{2}$:1:2:3. Therefore material requirements for mix 1 m³ of concrete are 0.125m³ water, 0.250m³ cement, 0.500 m³ sand, and 0.750 m³ gravel. The expected minimum compressive strength is approximately 150 kg/cm². To test the concrete mix consistency, place the concrete in your hand. The appropriate concrete mix will be achieved if the concrete can be grasped by your hand (Figure 33 – left). However, if the water is too much, the concrete mix will be “melted” in your hand (Figure 33 – right).

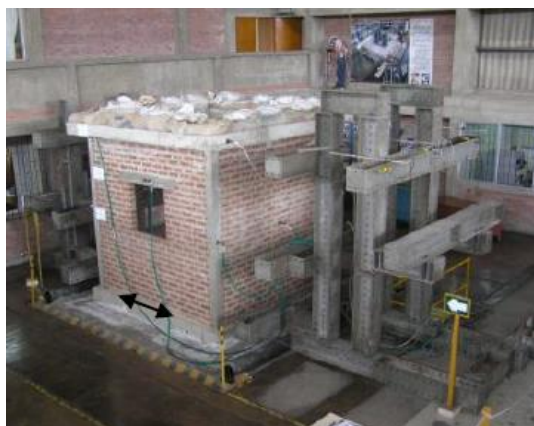
All of this 3 model of houses has dimension approximately 3m each in length and height with wall thickness 105mm. Sand bags were placed over the ring beams to simulate extra roof weight. Therefore the total load of each model was nearly less than 15ton, the limit load for PUCP shaking table. The models are based on Indonesian prevailing practice of non-engineered masonry construction.

Figure 56 – Model Structure for Shaking Table Test of Confined Masonry Brick-Walls Construction with Additional Reinforcement (Minowa, et al., 2010)

- Model A had no added reinforcement; it is similar to shaking table test conducted by NIED and Mie University as mentioned before in 3.5.3.
- Model B had a continuous reinforced concrete lintel beam over the door and windows openings, and also steel anchors between walls and columns at three positions. This model has the same concept with the Indonesian earthquake resistant masonry houses as can be seen in Figure 22, page 70 of this dissertation.
- Model C had an external wire mesh covering the surface of the walls, and a mortar cover was placed in East Wall. The wire mesh only wrapped the structure and did not act as ferrocement.

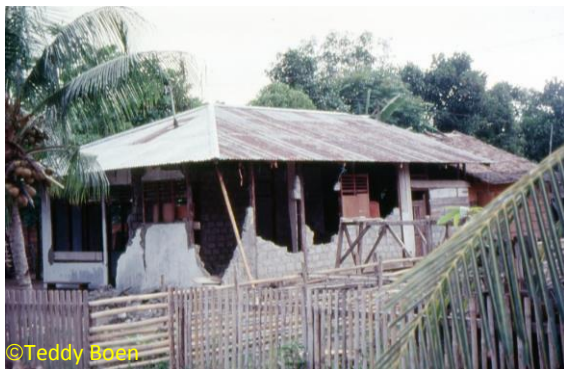
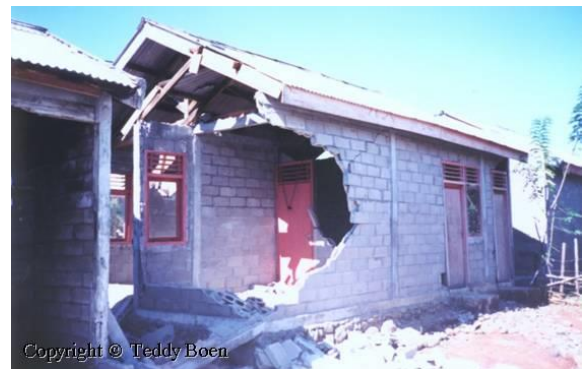
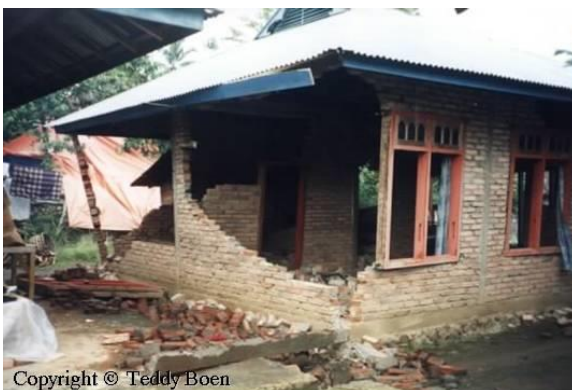
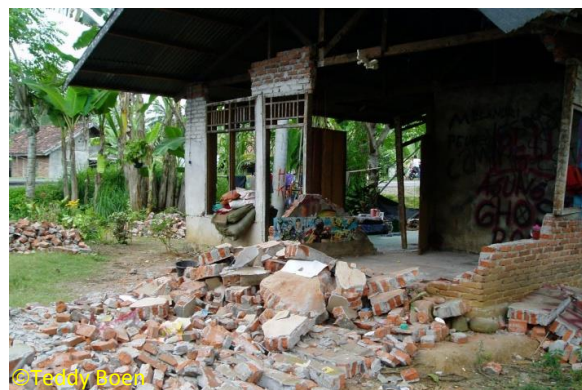
Figure 59 – Failure at Corners of Walls

1. Walls tear apart (Figure 58)
2. Failure at corner of walls (Figure 59)
3. Failure at corners of openings (Figure 60)
4. Diagonal cracks in walls (Figure 61)
5. Walls collapse (Figure 62)
6. Failure of connections (Figure 63)
7. Total damage (Figure 64)

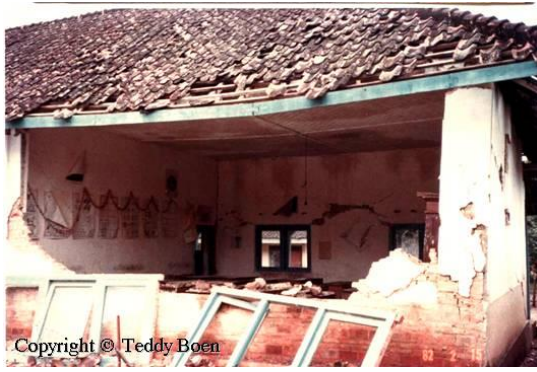
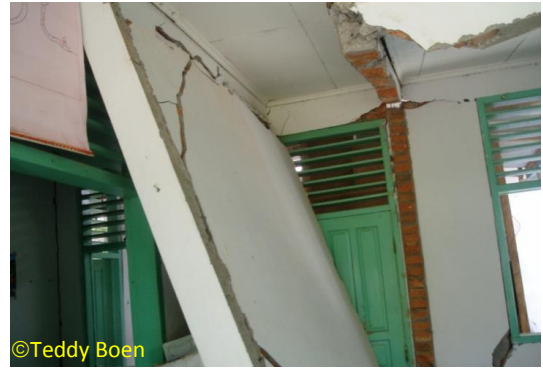
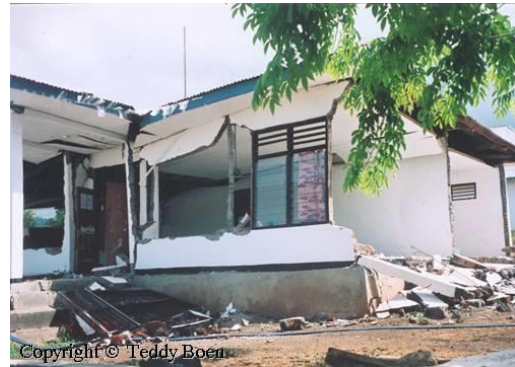
Figure 62 – Walls Collapse

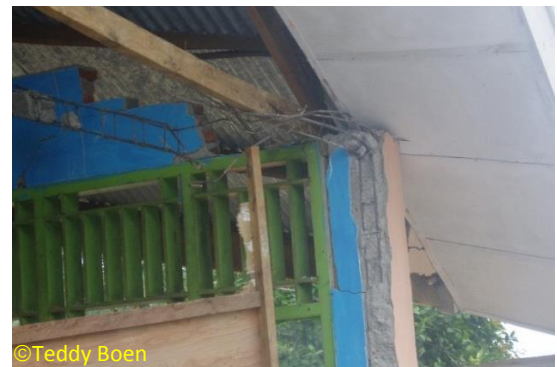
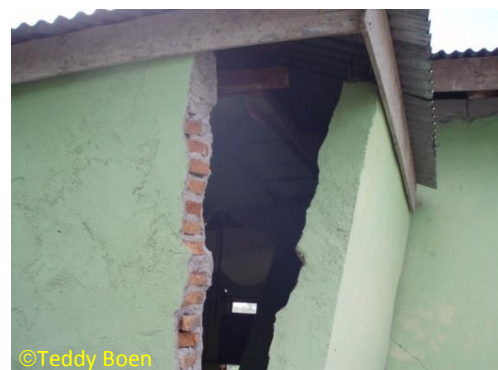
Figure 63 – Failure of Connections
